Surgepile Save @ Rocklick Prep Plant, ID No. 46-06448, District 4;

Justification for Alert

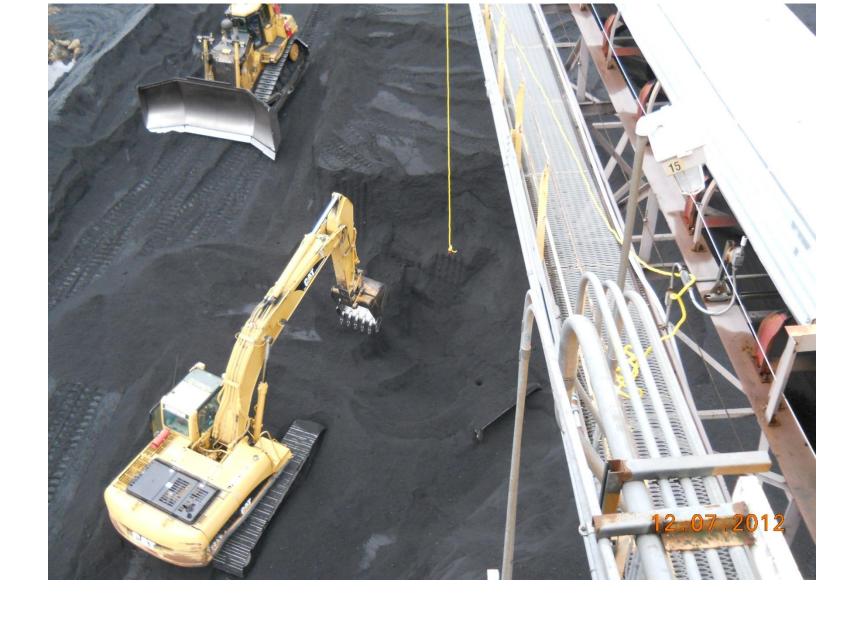
On December 5, 2012, 61 year old dozer operator was entrapped when the dozer fell into a void in a clean coal stockpile. The dozer trammed across the unidentified void and fell through covering the dozer and trapping the operator under approximately 20 feet of coal. He was trapped for approximately 3 hours, 45 minutes.

Dozer buried under 20' of coal

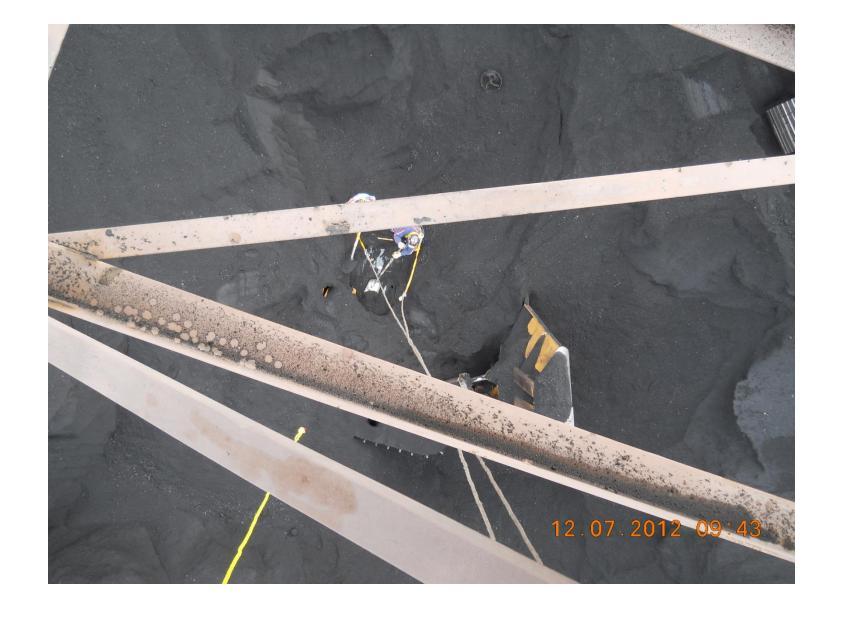
Buried miner was trapped for nearly 4 hours and used two scsr's

- cool packs provided in the cab
- additional available fluids
- more SCSR's (had the dozer been buried deeper more rescue time would be needed)
- different type of SCSR which allows miners to drink while using them
- having a barrier available to shield oneself against the heat generated from the SCSR

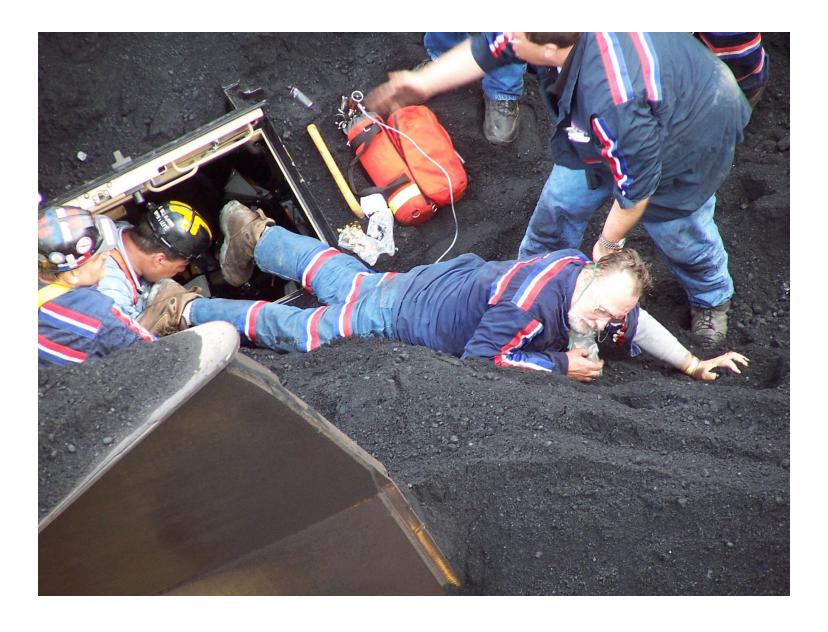
Inspectors on site stated that heat in the cab was unbearable. Heat sources were from the engine, SCSR's, and body heat.

working through the MSHA/AEM alliance to encourage manufacturers to study and develop engineering solutions to prevent heat stress including cooling vests provided in the cab of surgepile dozers.
